DILEMMA OF SUSTAINABLE ROOF FORMS IN WARM-HUMID CLIMATIC ZONES: A SURVEY OF PARAPET ROOFS IN KUMASI, GHANA

Twumasi - Ampofo K.¹ and Oppong, R.A.²

1 Building and Road Research Institute-CSIR, Kumasi, Ghana

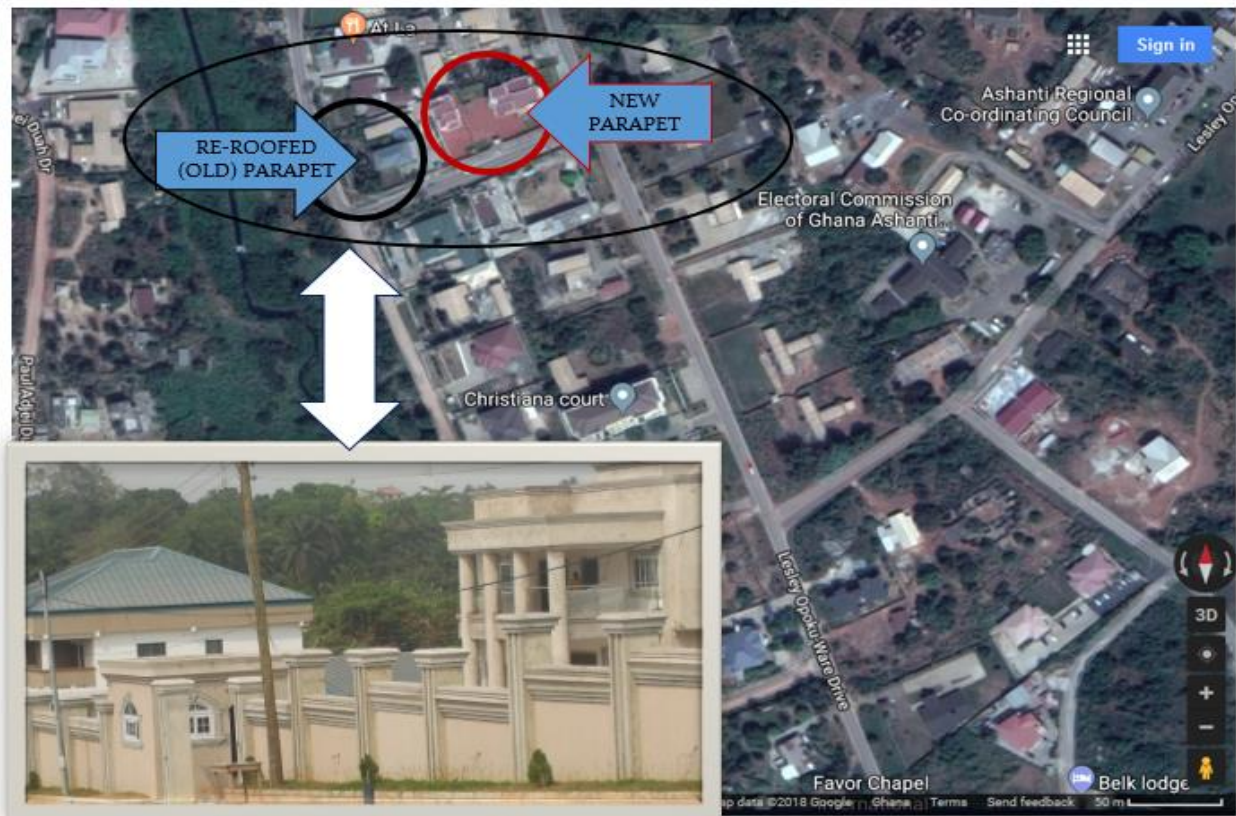
Fig. 2. Green re-roofed parapet building with a newly constructed concrete parapet roof next to each other off Lesley Opoku-Ware Drive. Source: (inset) Authors, 2016; Google maps, 2018.

From Table 1, ninety (90) of the buildings studied had been re-roofed with its parapet completely covered with long span aluzinc sheets while thirty-six (36) of the buildings have new roofs with concrete parapet indicating clearly the dilemma of roof forms as shown in Figures 2 and 3. More than 50% (64) of the respondents living in re-roofed buildings inherited from their parents.

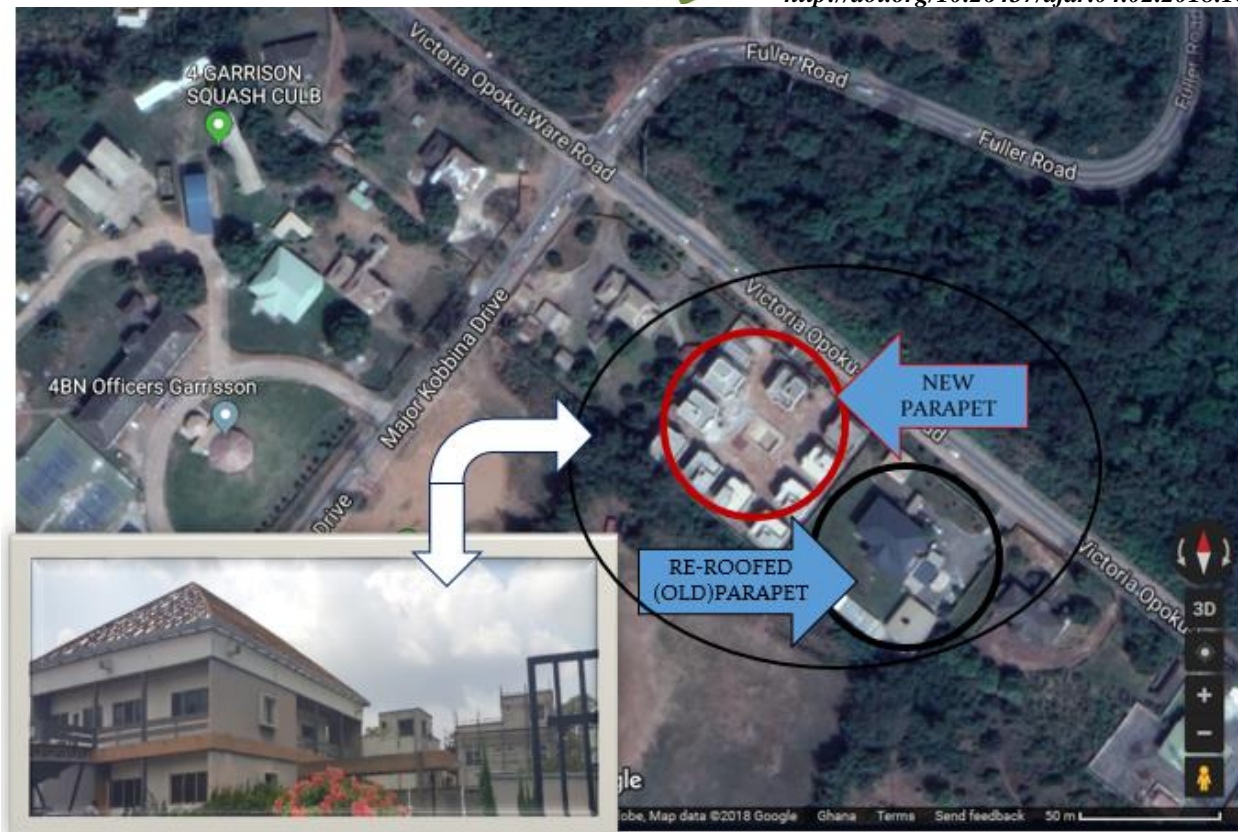
Fig. 3. A parapet roof completed in 1976 being re-roofed and a new concrete parapet roof building on the next plot of land along Victoria Opoku-Ware Road. Source: (inset) Authors, 2016; Google maps, 2018.

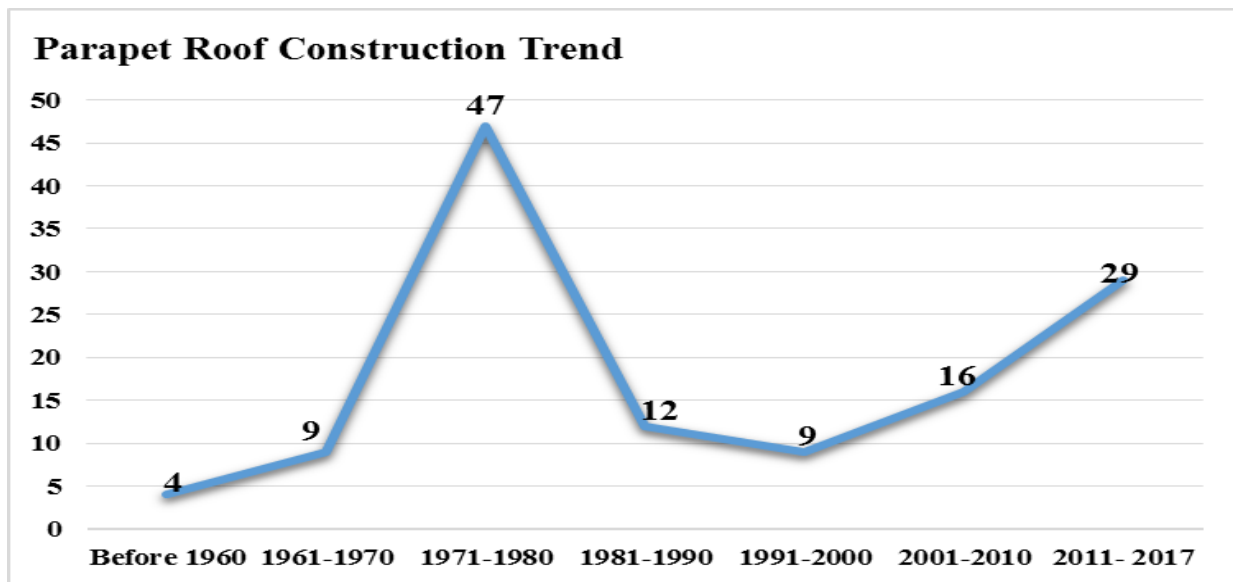
Fig. 4. Parapet roof construction trend. Source: Authors, 2016

Table 3 indicates that 72 out of the 126 buildings studied were built before 1990 which falls within Hutchinson’s (2004) definition for sustainable roofs with lifespan up to three decades while 54 buildings were completed less than 27 years ago. It is worth noting that the crave for parapet roofs rose to its peak in the 1980s (47), reduced to 9 in the 2000s and rose again up to 29 from 2011 to 2017 (Figure 4).

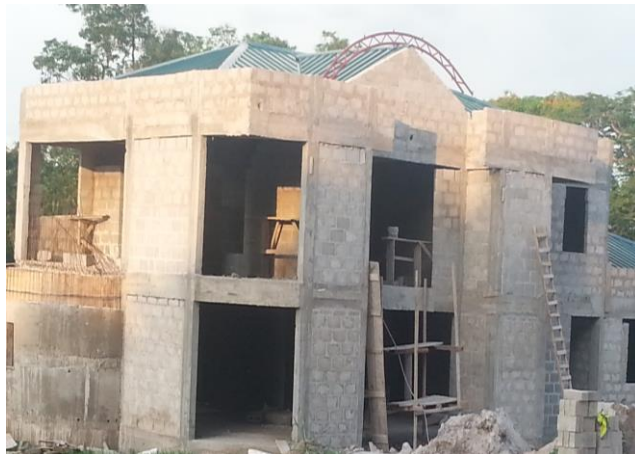
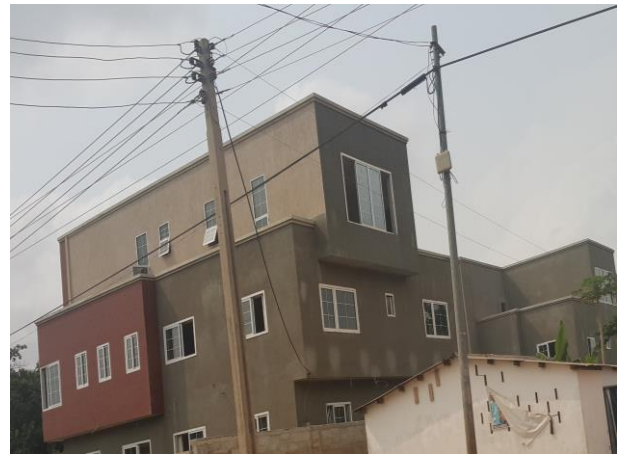
Fig. 5. New Concrete Parapet Roofs. Source: Authors, 2016

The new parapet roofs for this study are for buildings completed between 1991 and 2017 which has a total of 54 with 18 of them re-roofed. This section however, deals with 36 out of the 54 newly constructed buildings not re-roofed (Figure 5). Parapet roofs (not re-roofed) as shown in table 3.4 indicates an increase trend starting from 5 within 1991-2000, through 9 within 2001-2010, to a majority (22) within 2011 and 2017.
