**EFFECT OF SPEED RAMPS ON FIRE TENDER AND SERVICE DELIVERY:
A CASE STUDY OF THE CENTRAL REGION, GHANA**

Akowuah, E.¹, and Andoh, P. Y.²

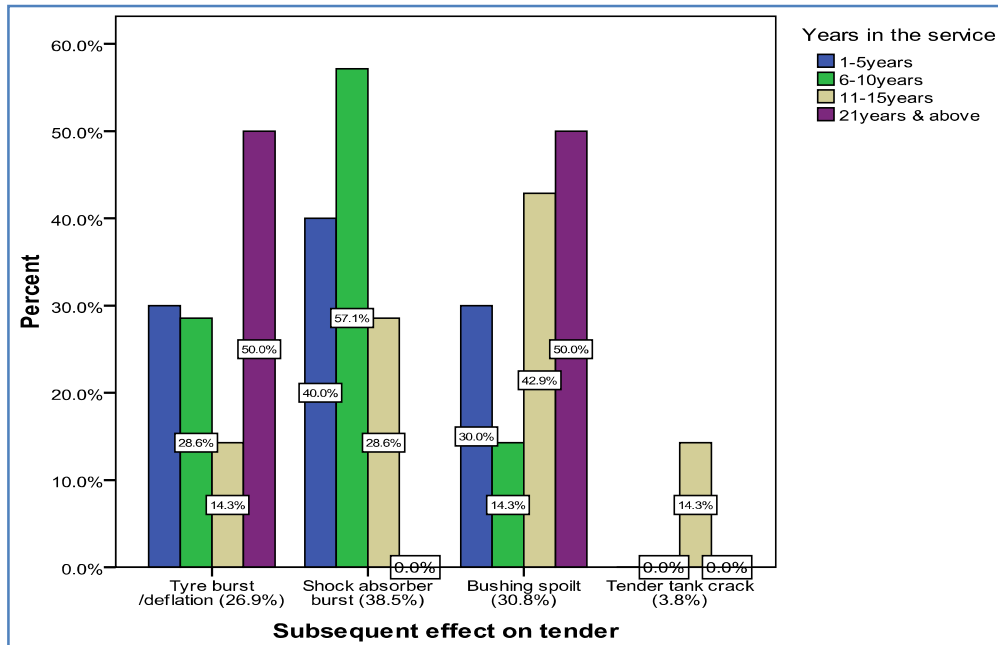
Figure 2: Effect of wheel-to-ramp banging on fire tender per driver service experience

Apart from the fact that most drivers (92.9%) admitted that ramps could cause water tank of fire tender to crack, it is more evident in the responses obtained in Figure 2 as

more specific damages caused to tender parts due to wheel-to-ramp banging were captured. Most of the damage are seen in the shock absorbers (38.5%) and followed by spoilt bushings (30.8%). Tyre deflation and/or burst accounted for 26.9% of damage whilst tender water tank cracks accounted for only 3.8% as reported by drivers in Figure 2.

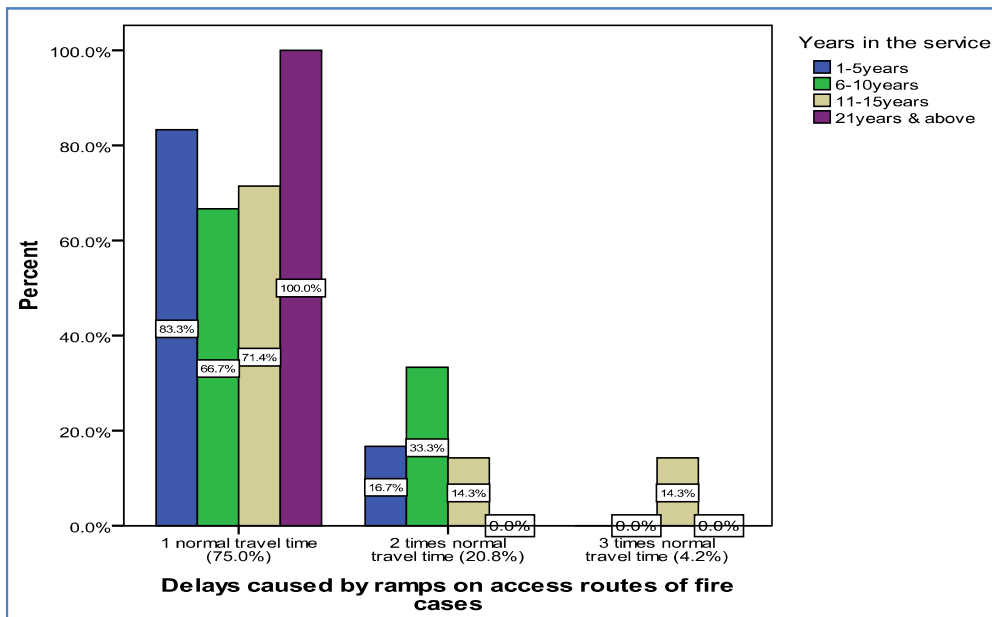
Figure 3: Delays caused by ramps as assessed tender drivers per service experience

Fire tender drivers’ introspective account on factors affecting the service delivery of Ghana National Fire Service has yielded interesting results. More drivers (75.0%) believe that speed ramps delay their work as much as one equivalent standard travel time. 20.8% of drivers asserted that it cost them twice and 4.2% of them feel that ramps could triple the commuting time of fire crew. The details of four different driver groups per experience are depicted in Figure 3. When the delays in fire crew movements in central region were further examined and compared using a re-organized data from all the three well resourced stations within the Cape Coast metropolis some coincidence and few disagreements were discovered. From Appendix B1, it is observed that at all times the actual times (minutes) were equal or greater than the recommended standard times (minutes) except in two cases where the fire crews arrived at an earlier time than expected. In the case of non-metropolitan areas of the region (Neville et al, 1989) - where the fire stations are not fully resourced – the issue of responders’ delay would surely exacerbate the problem of poor incident management by the Ghana National Fire Service.
